St. Lawrence of Canterbury Roman Catholic Church

Planned Maintenance Inspection Report

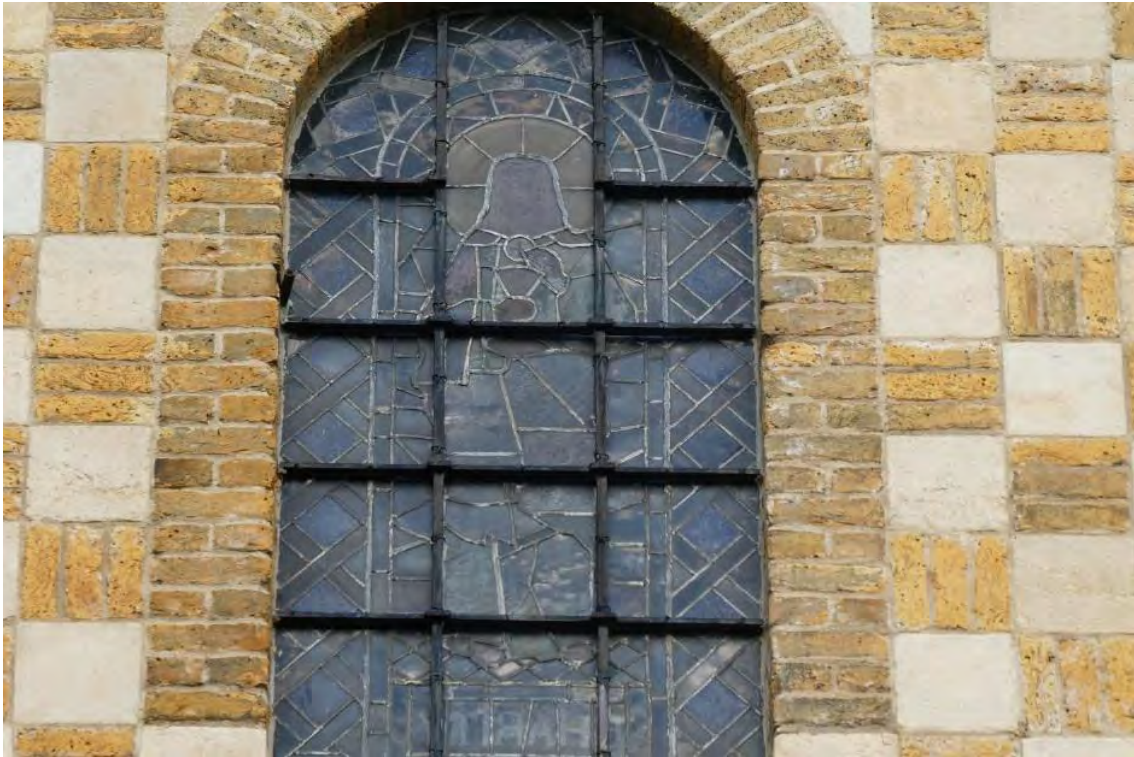
Photo 5 (Below): General overview of peeling paint to the crittal windows to the church.

The decorations to the external metal and joinery are in fair condition. Allow for next redecoration cycle in years 3-5. High level access will be needed to reach the cast iron gutters and downpipes.

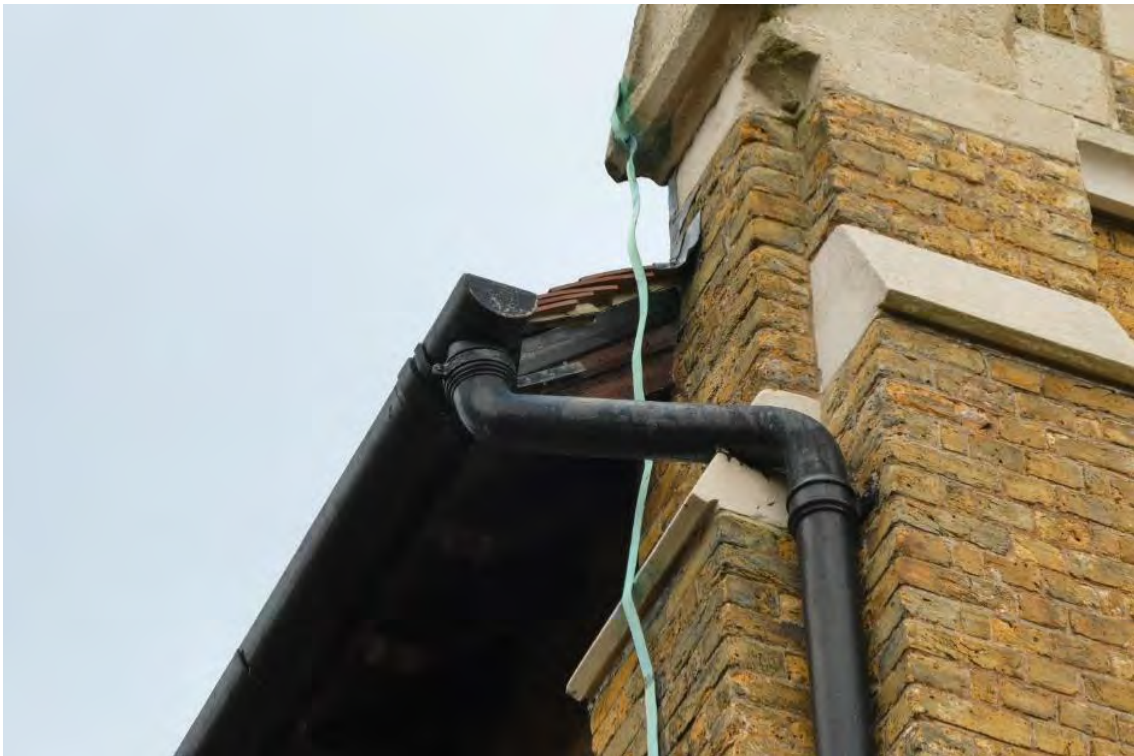
There is a section of loose lightning conductor tape at high level to the west elevation. Lightning protection systems should be inspected and tested annually and form part of the general maintenance budget.

Photo 6 (Below): General overview of loose lightning conductor strip to the west elevation of the church.

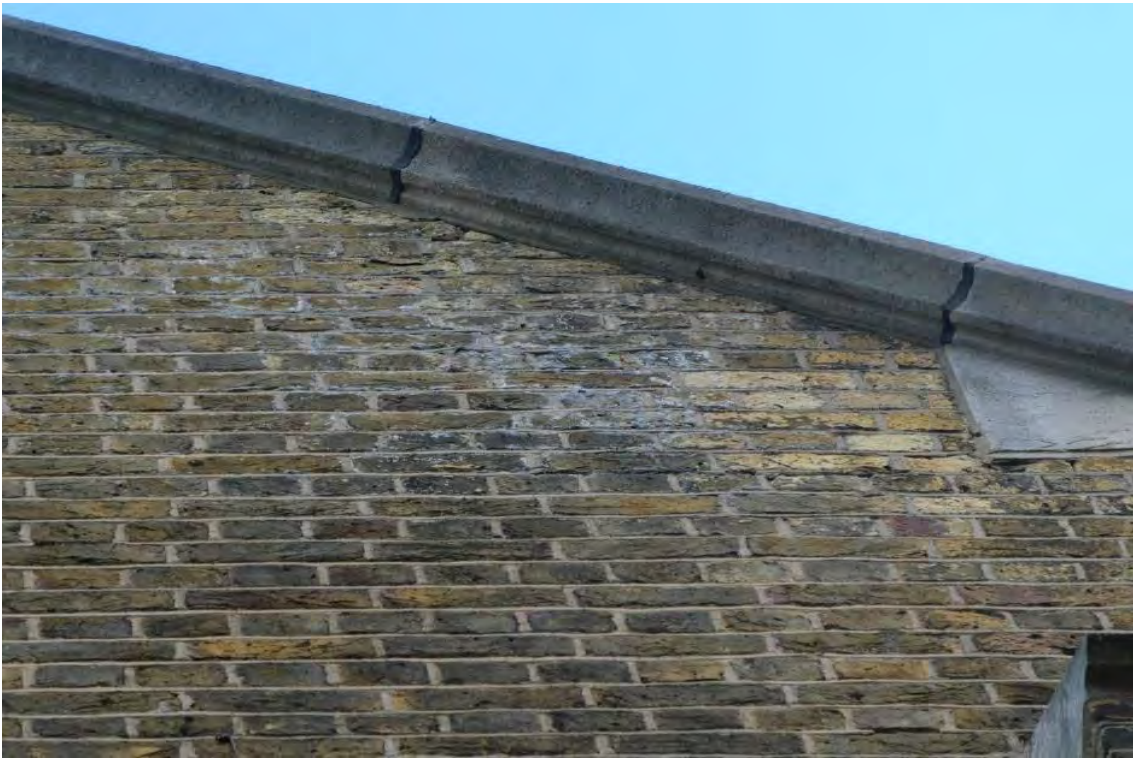
The tile coverings generally appear in good condition, with no significant defects, slipped or damaged roof tiles noted. There is a small area of damp at high level to the west transept gable end, which the church report have been ongoing for many years. This damp is likely caused by the lack of or failure of the damp proof course (dpc) beneath the coping stones. Efflorescent staining is visible to the external brick work in this location. Previous remedial work to seal the coping stone joints is also evident.

Photo 7 (Below): Efflorescence staining to the gable end of the west elevation transept. Staining coincides with internal damp at high level.

| • Repairs to the coping stones and brick work to the gable end to the west transept of the church to remedy the internal damp. | 15,000 excl. VAT and fees |

To fully remedy the issue then the coping stones should be removed, damp proof course renewed and the coping stones reinstated / renewed and the coping stone joints re-pointed. These works would require scaffolding or a cherry picker to be located on the access road to the car park. Allowance made for scaffolding / cherry picker hire and works to the coping stones in years 0-2, but these works could be postponed if the damp ingress does not worsen. Further allowance for similar repairs to the other areas of coping stones has been made in years 6-10. These works can also be adjusted as required and to reflect any issues with internal water penetration that occur.

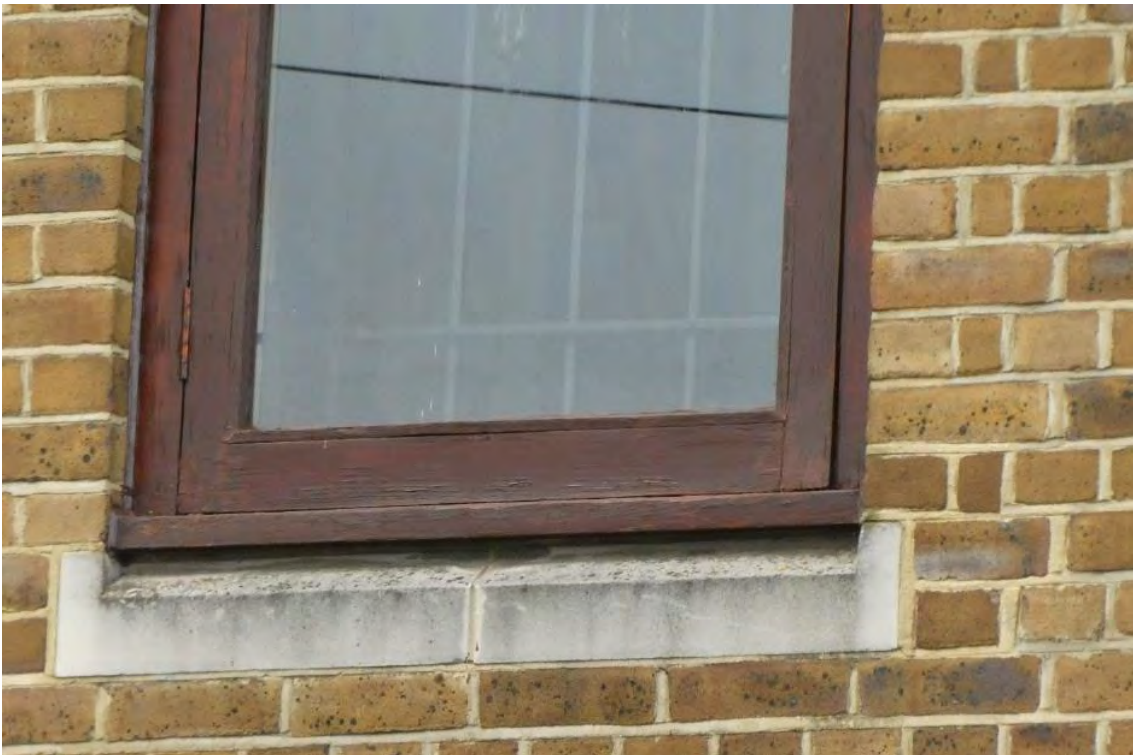
There are minimal decorated items across the community centre building apart from the timber windows, doors and fascia board. The external joinery is exhibiting signs of weathering, especially to the east elevation and cyclical redecoration is now recommended. Allow for next redecoration cycle in years 0-2 and periodic redecoration every 7 years thereafter.

Photo 8 (Below): Overview of flaking decorations to the timber windows to the community centre.

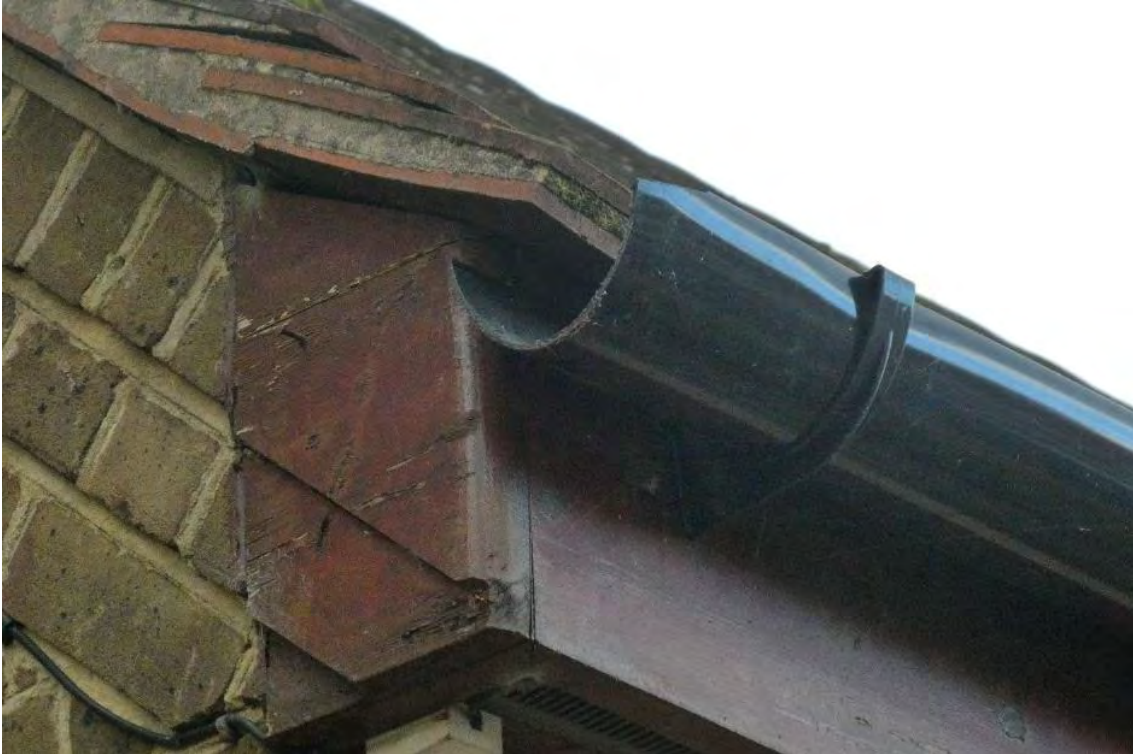
- To the east elevation to the top left of the entrance doors - the gutter is missing the stop end cap allowing water to discharge onto the external paving.
- To the two storey section of the north flank elevation adjacent to 1 Hamilton Road - leaking gutter joint.

Photo 9 (Below): Overview of missing end cap to uPVC gutter to the east elevation of the community centre.

Allowance has been made for a roofer to attend and rectify current leaks.

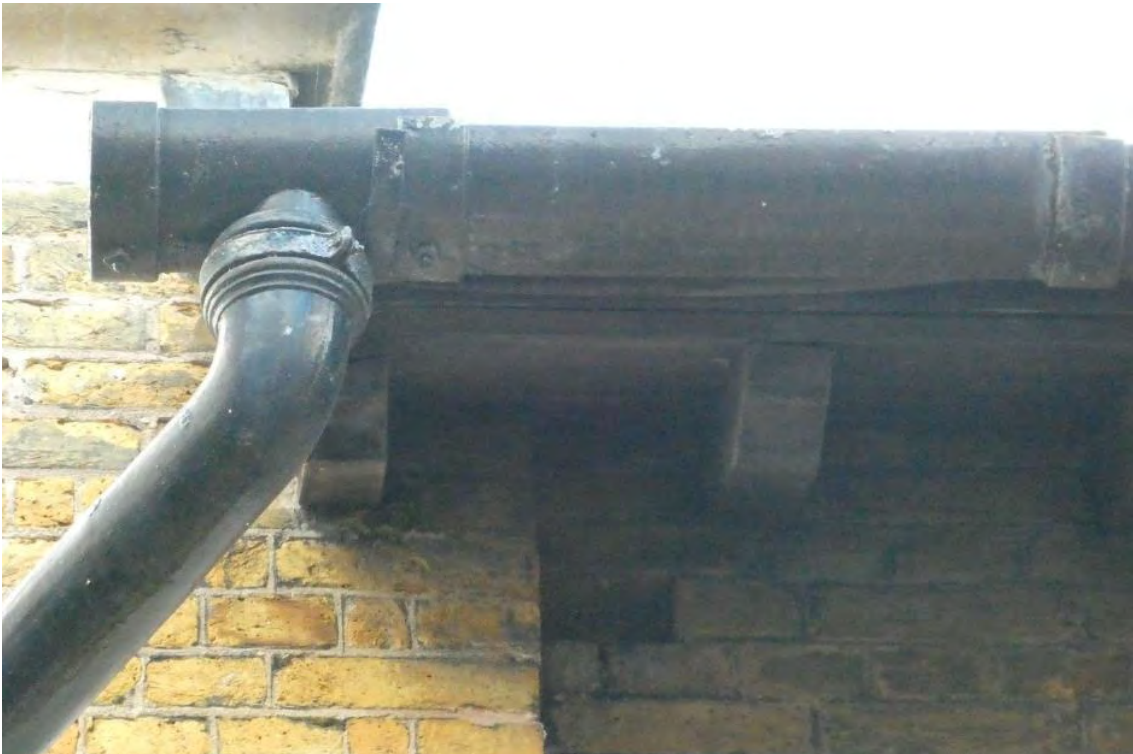
The rainwater goods comprise of decorated cast iron downpipes and gutters to the side elevations. Most cast iron rainwater goods appear visually in good condition with the exception of a section of gutter to the east elevation at high level above the side aisle. In this location the guttering has been installed incorrectly resulting in rainwater seeping through the joints during heavy rainfall. This is causing water to leak down onto the side aisle roof with water run off staining visible to this roof. This section of guttering should be accessed and replaced.

Photo 10 (Below): Overview of the rainwater goods to the east elevation of the church showing poor guttering detail to the church. There is a leak in this location that has caused staining to the roof tiles below.

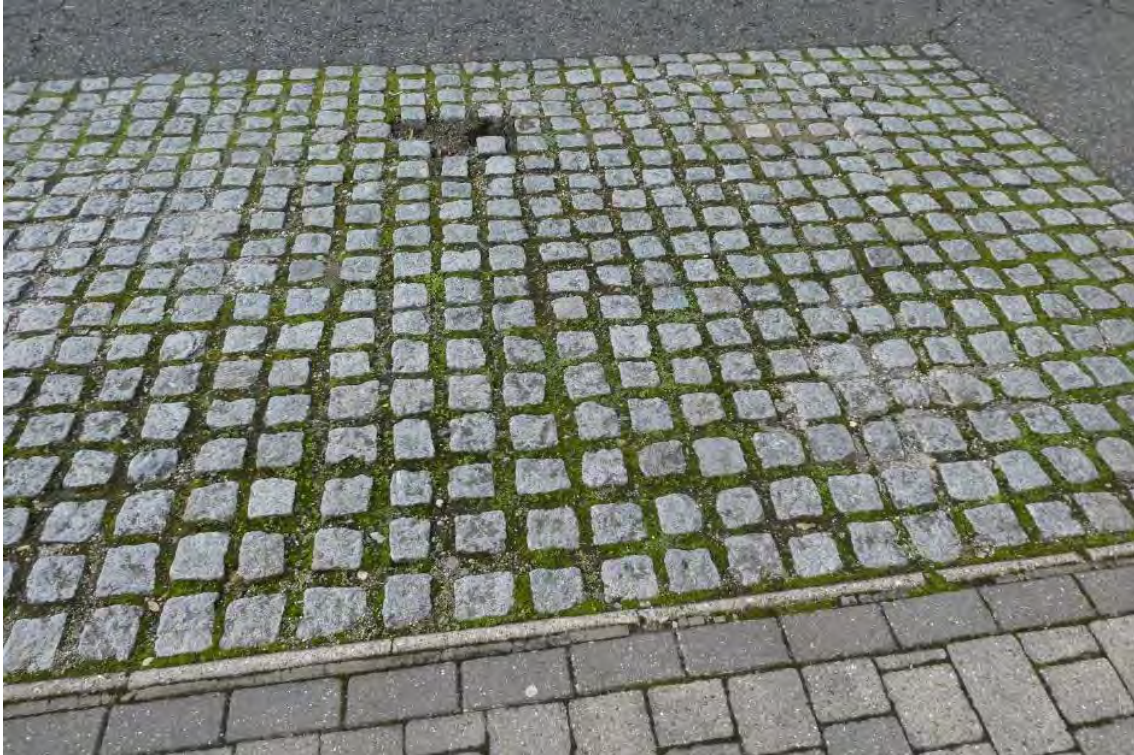
The cobble road surface and brick set parking spaces to the front of the church are generally in good condition with only a small number of cobbles missing. It is advised to budget cost to replace these cobble stones to prevent trip hazards.

Photo 11 (Below): Overview of missing cobble stones to the parking spaces in front of the main entrance.

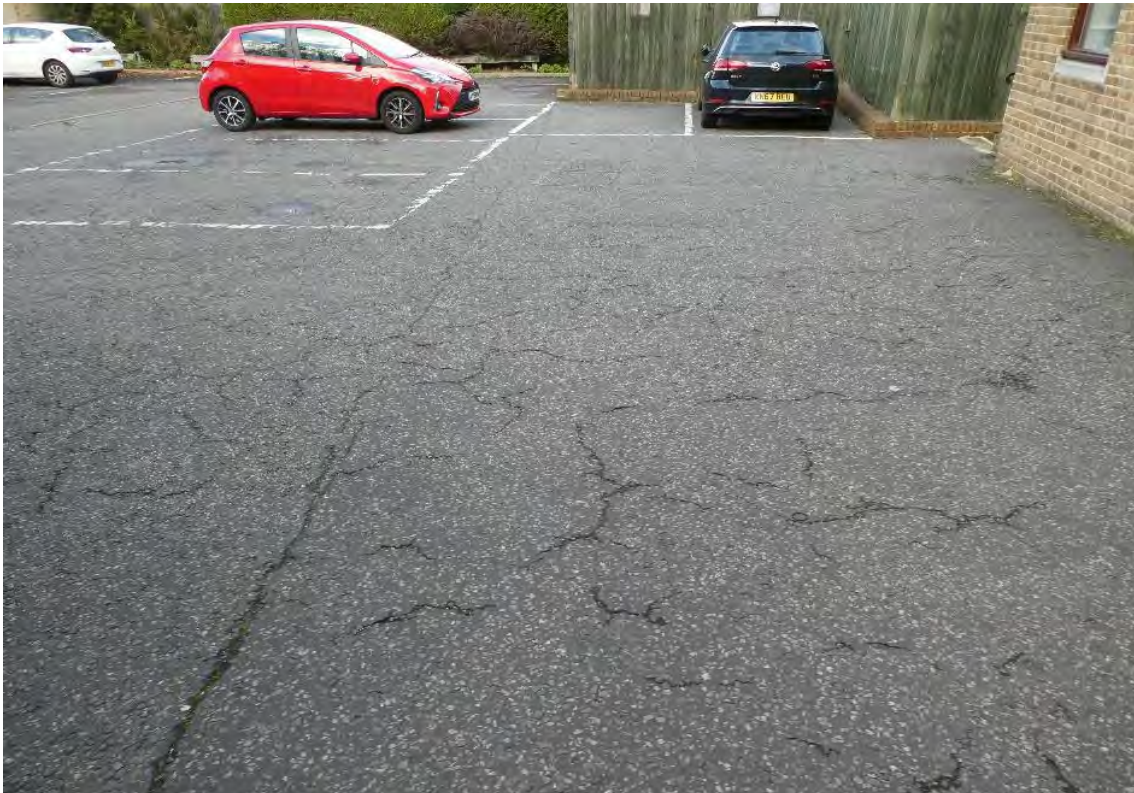
Hardstanding to the access road and car park area is formed from hot rolled asphalt with coated chippings with thermoplastic linings to the car park spaces. There is general cracking to the asphalt surface throughout the access road and car park surface. There is no requirement for immediate works, but allowance should be made to completely re-surface the area in years 6-10. The thermoplastic lining is also deteriorated and will require renewal as part of the surfacing works.

Photo 12 (Below): Overview of surface cracking to the car park surface. Renewal of the car park and access road surface will be required in the medium term as the cracks widen.

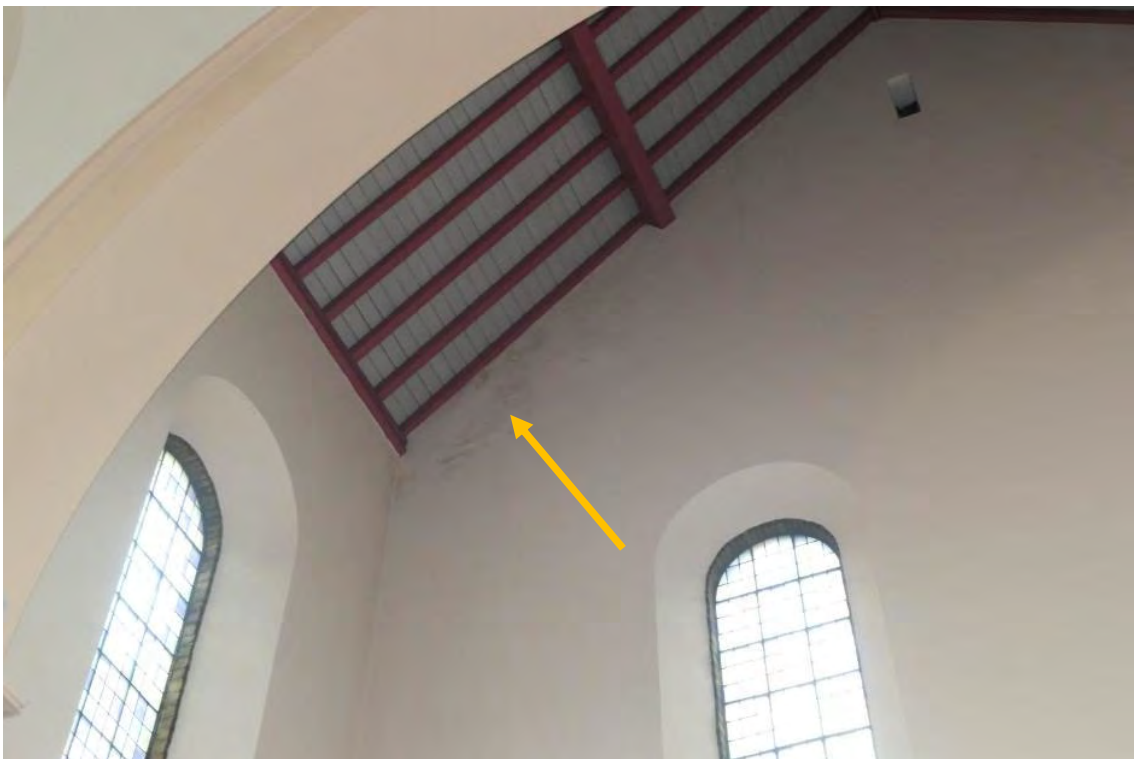
Photo 14 (Below): Overview of damp staining to the top left side of the gable end to the west transept.

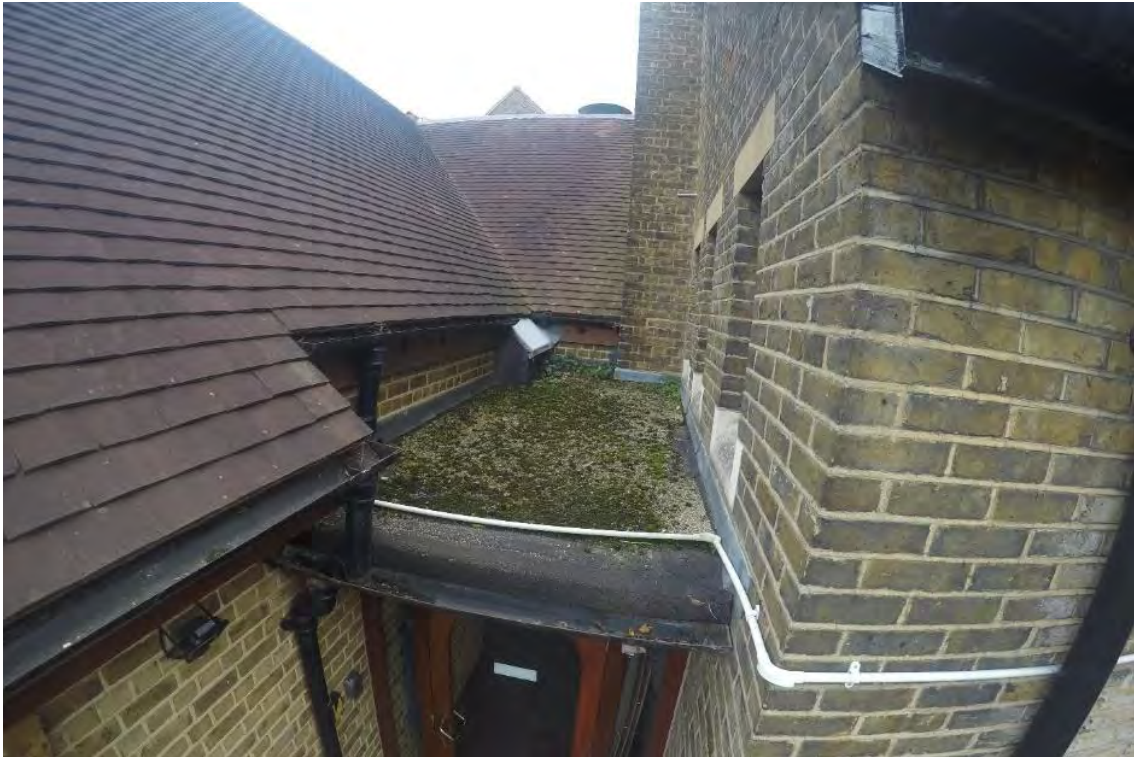
There are 3 No flat roof areas to the building that are all provided with a bituminous felt covering. The felt coverings appear to be the original felt coverings installed during the construction of the building in 1992. These coverings are now circa 30 years old and felt roof surfaces typically have an approximate life expectancy of 25-30 years before they begin to deteriorate and fail. Whilst there are no current issues with water ingress but we would recommend that the felt surfaces are renewed in years 3-5 to ensure the building remains watertight. Scaffolding will be required to facilitate the works.

Photo 19 (Below): General overview of the felted flat roof to the community centre rear entrance doors.

| • Renewal of the felt roof coverings to the community centre flat roof areas as they reach life expiry. | 6,000 excl. VAT and fees |

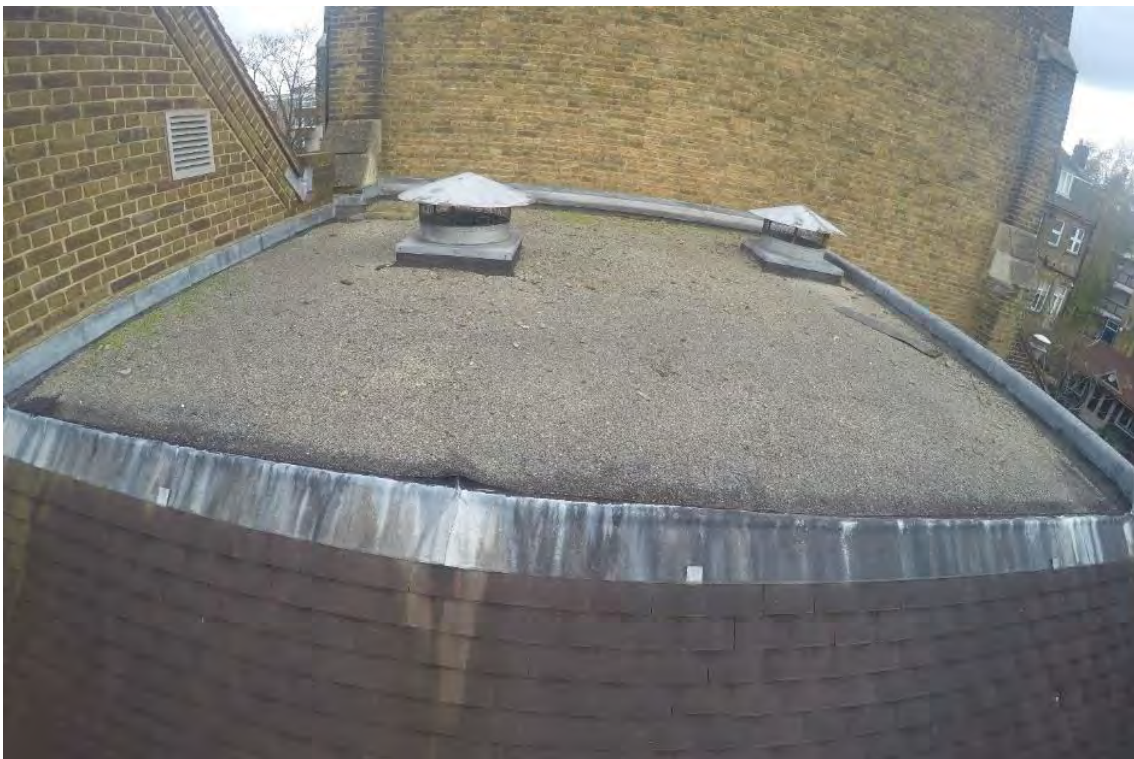
Photo 20 (Below): General overview of the main felted flat roof to the community centre hall.

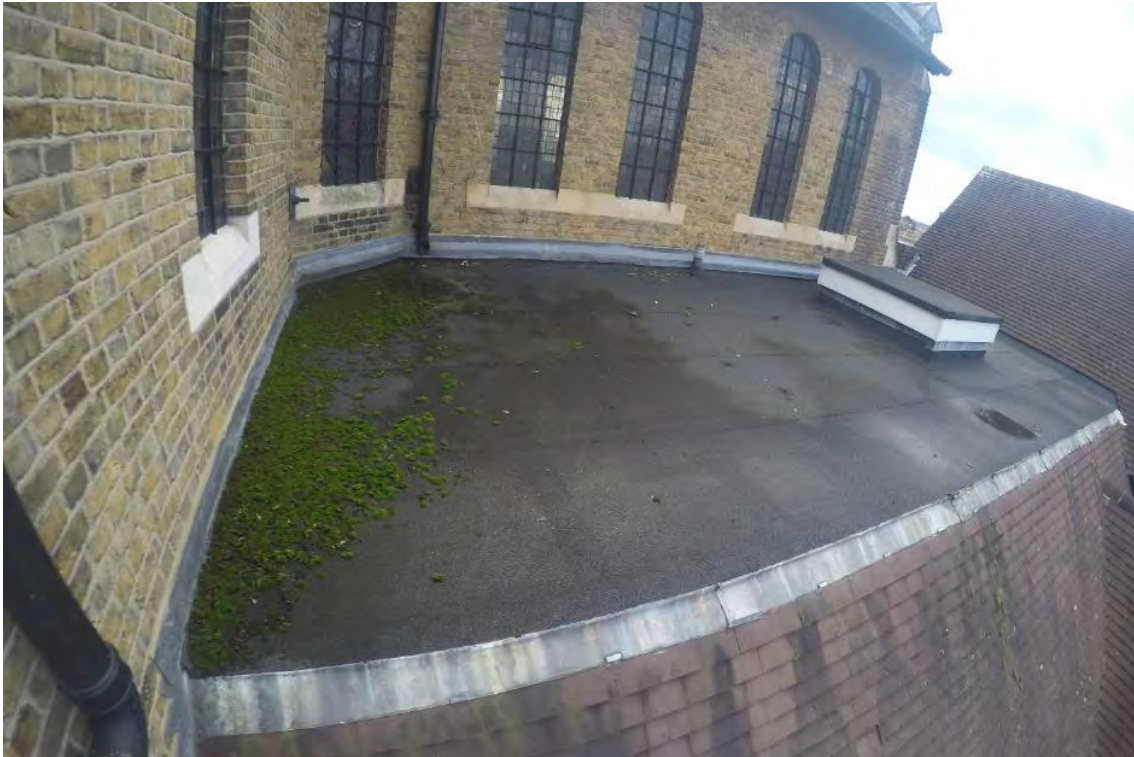
Photo 21 (Below): General overview of the felted flat roof to the two storey section of the community centre.

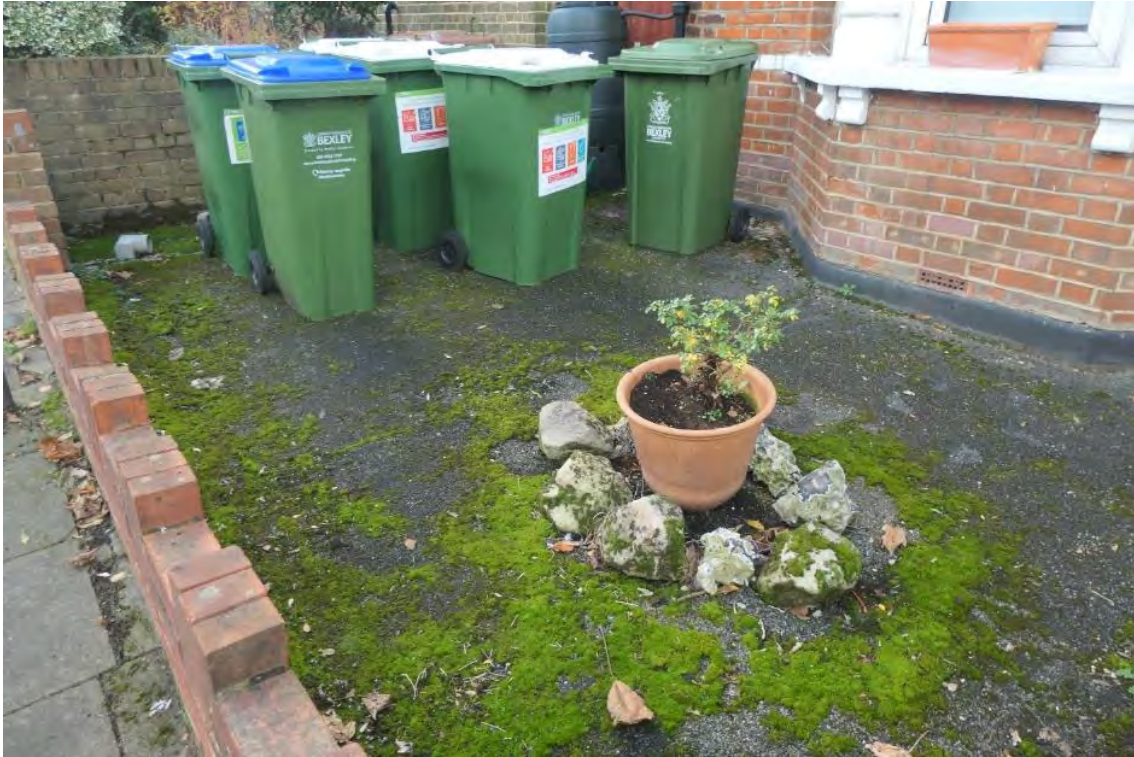
There is hot rolled asphalt to both front yard areas. There is vegetation growth to the asphalt that should be cleared as part of a regular maintenance regime. The front yard areas are currently fit for purpose but you may want to consider renewing the surface or replacing it with an alternative finish as the asphalt deteriorates further.

Photo 25 (Below): Overview of asphalt hardstanding to the front drive of 1 Hamilton Road.

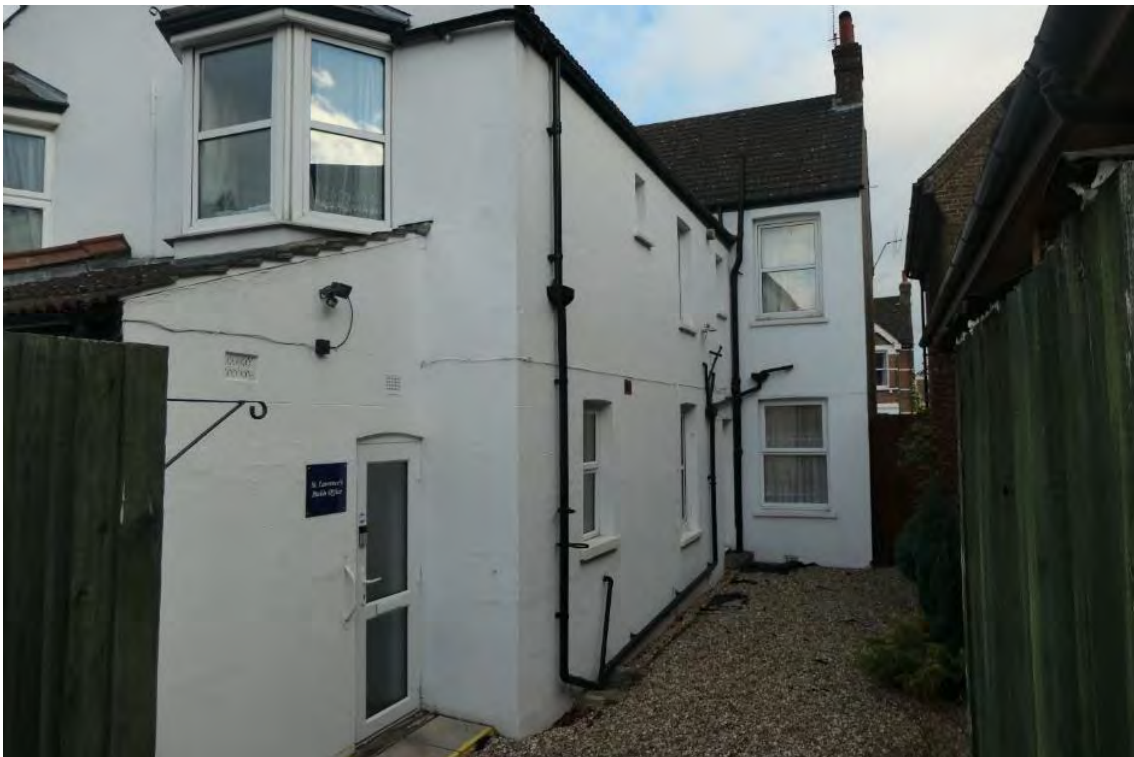
There are previous patch repairs and a general rough finish to the sections of painted render. The render is also likely to be a sand and cement based render rather than a lime render. This can create issues with the breathability of the solid external brick walls and result in internal damp problems. However, as there are currently no significant issues with internal damp, it would not be justifiable to hack off and replace the render with a lime based render.

The brick work and mortar pointing is in fair condition with no significant issues, however there are areas of missing or eroded mortar pointing, notably to the outrigger extension. There is hairline cracking to the render finish to the rear single storey extension.

Photo 26 (Below): Overview of the render finish to the rear elevations of 1 Hamilton Road.

As part of the next external decoration works we would recommend that some repairs are undertaken to areas of missing mortar pointing and cracked render.

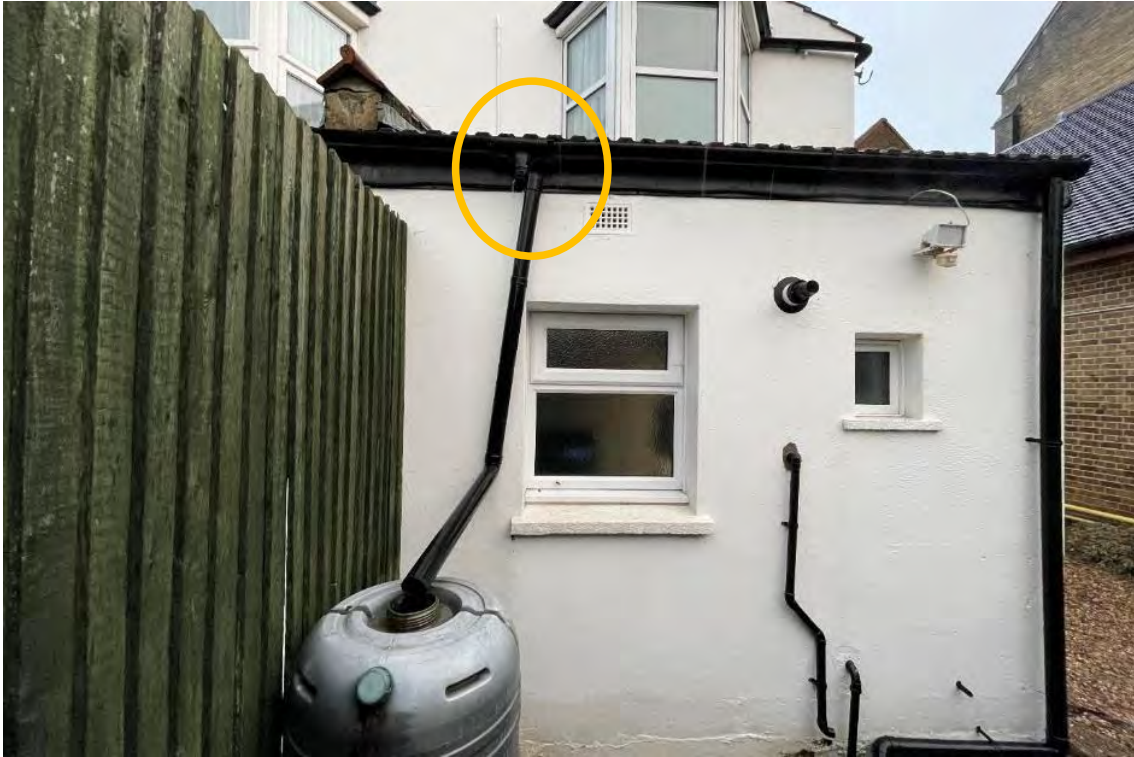
The uPVC rainwater goods across both properties are in fair condition. There is a disconnected downpipe to the rear elevation of 1 Hamilton Road that should be reconnected asap. Allowance should also be made for the future replacement of the rainwater goods to coincide with the proposed roof covering renewal works.

Photo 27 (Below): Loose downpipe to the rear elevation of 1 Hamilton Road.

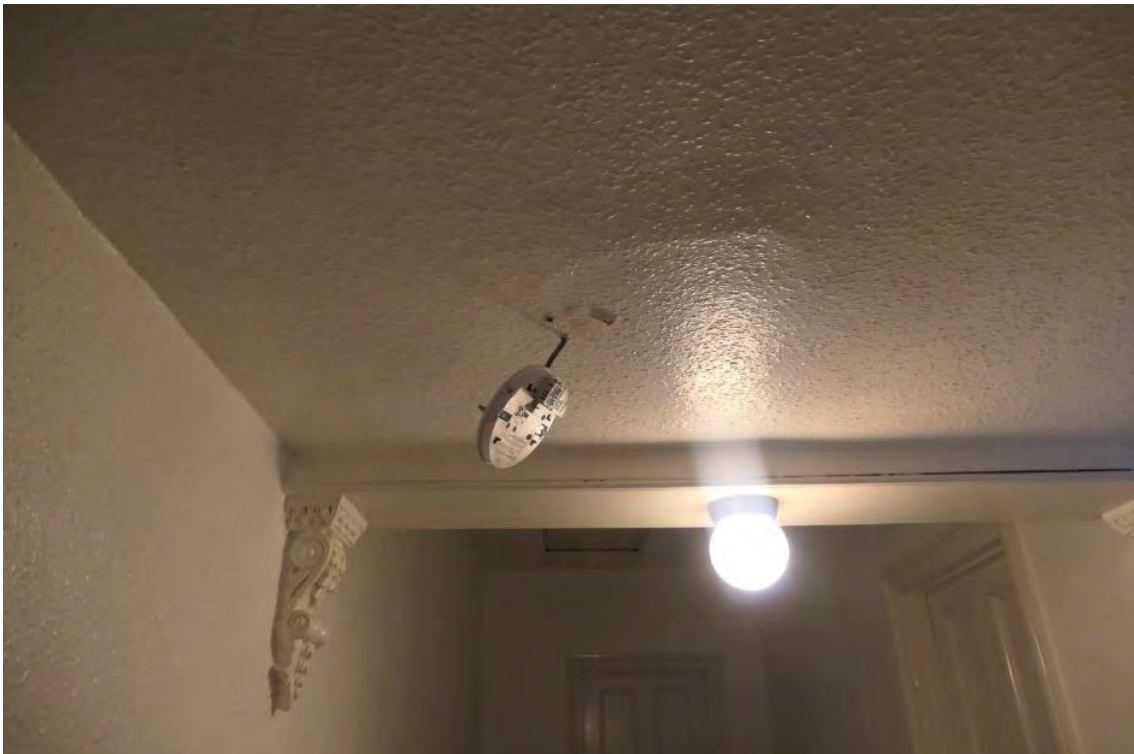
Photo 28 (Below): Overview of a loose smoke alarm detector to the first floor within 1 Hamilton Road. The first floor is currently not used and requires refurbishment.

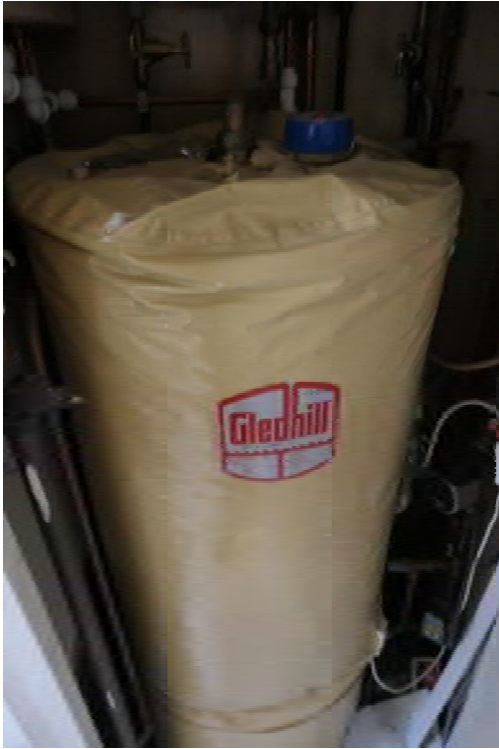
Photo 29 (Below): Overview of the hot water tank within 1 Hamilton Road. Budget to renew in the short term.

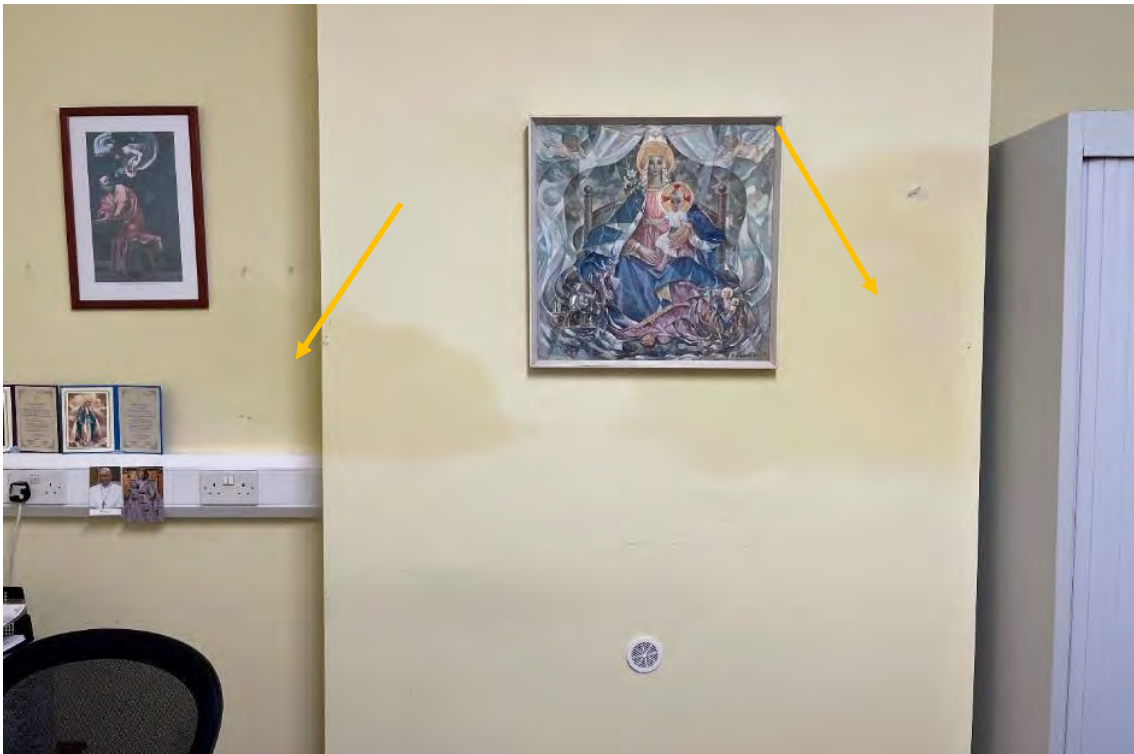
There is 1No chimney stack to the main roof to 1 Hamilton Road. The chimney stack to 3 Hamilton Road has been lowered and removed. The chimney stack brick work appears in sound condition from ground level inspection. There are no ventilation caps present to the chimney pots. We recommend that ventilation caps are provided to the pots (2No) to help prevent water ingress now the fireplaces are not active (damp is present to the chimney breast within the ground floor priest office).

Photo 32 (Below): Overview of internal damp the ground floor chimney breast within the priest office to 1 Hamilton Road.

| • Remedial repairs to ground floor priest office in 1 Hamilton Road to eradicate damp issues to the chimney breast. | 2,500 excl. VAT and fees |

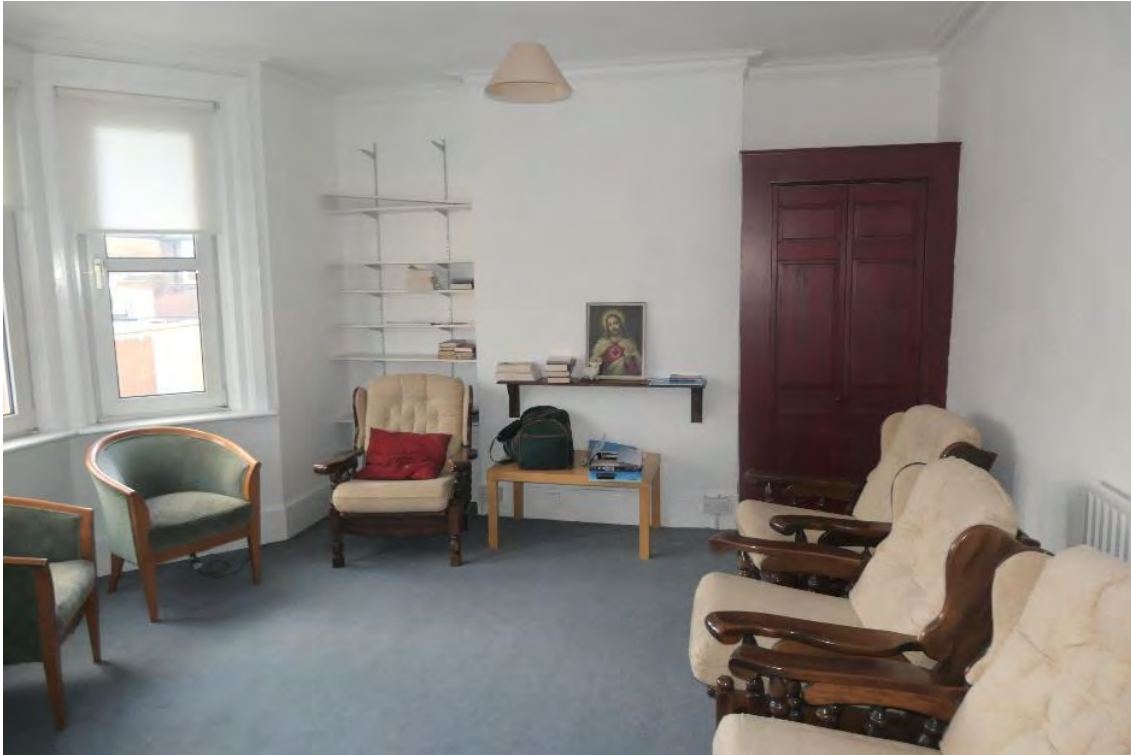
Photo 33 (Below): General overview of ground floor areas to 1 Hamilton Road which would benefit from redecoration and renewal of floor finishes within the next 5 years.

| • Renewal of floor finishes and internal decoration of 1 Hamilton Road. First floor rooms are currently vacant and not used (no costs for the first floor included). | 7,000 excl. VAT and fees |

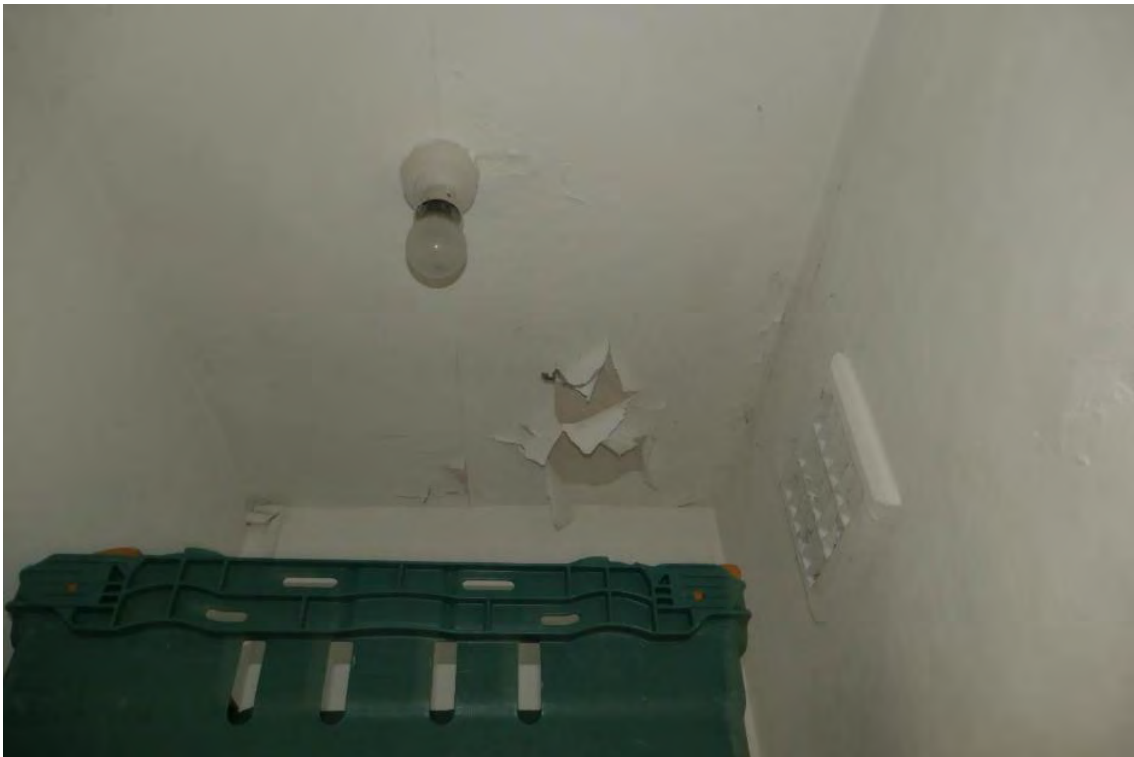
Photo40 (Below): Overview of peeling paint within the utility cupboard of 3 Hamilton Road.
